**IMMERSED MEMBRANE BIOREACTOR  
PERFORMANCE EVALUATION:  
TWELVE PINES SEWAGE TREATMENT PLANT  
SUFFOLK COUNTY, NEW YORK**

**FINAL REPORT 04 -04  
DECEMBER 2004**

**NEW YORK STATE  
ENERGY RESEARCH AND  
DEVELOPMENT AUTHORITY**

Prepared by  
**O'BRIEN & GERE ENGINEERS, INC.**  
Syracuse, NY

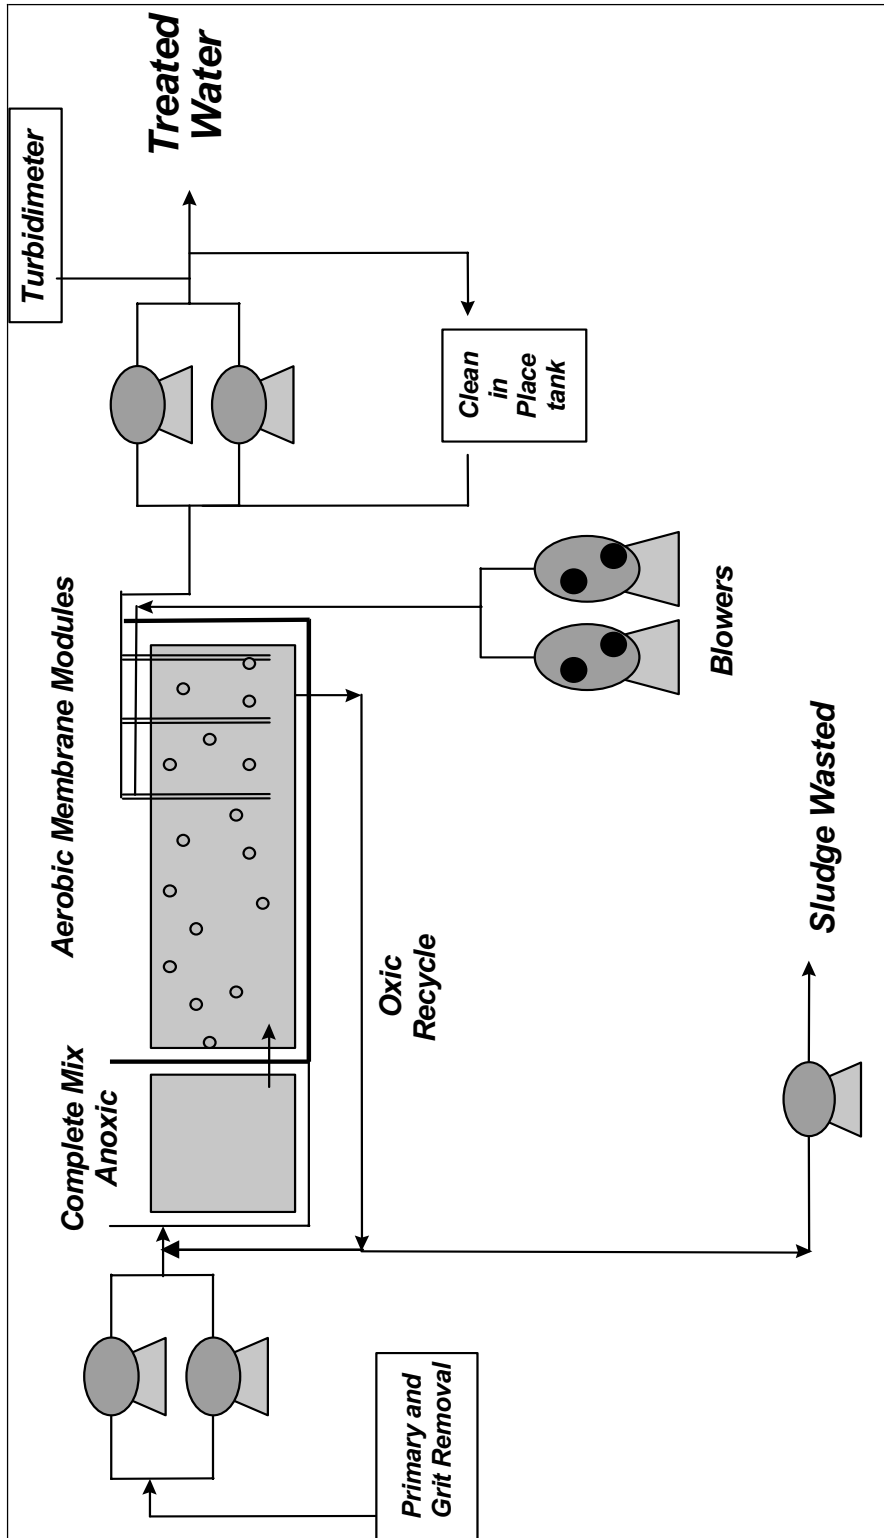
Figure 3-1 Typical MBR Process Flow Schematic

The MBR process technology consists of a suspended growth biological reactor integrated with an ultrafiltration membrane system. Figure 3-1 is a process flow schematic of the MBR process used for carbonaceous removal and nitrification/denitrification. Essentially, the ultrafiltration system replaces the solids separation function of a conventional activated sludge system (secondary clarifiers and sand filters). For municipal wastewater applications, the membrane filter consists of hollow fiber material with a 0.04 micron nominal pore size. This pore size precludes the passage of particulate material from being discharged with the effluent.

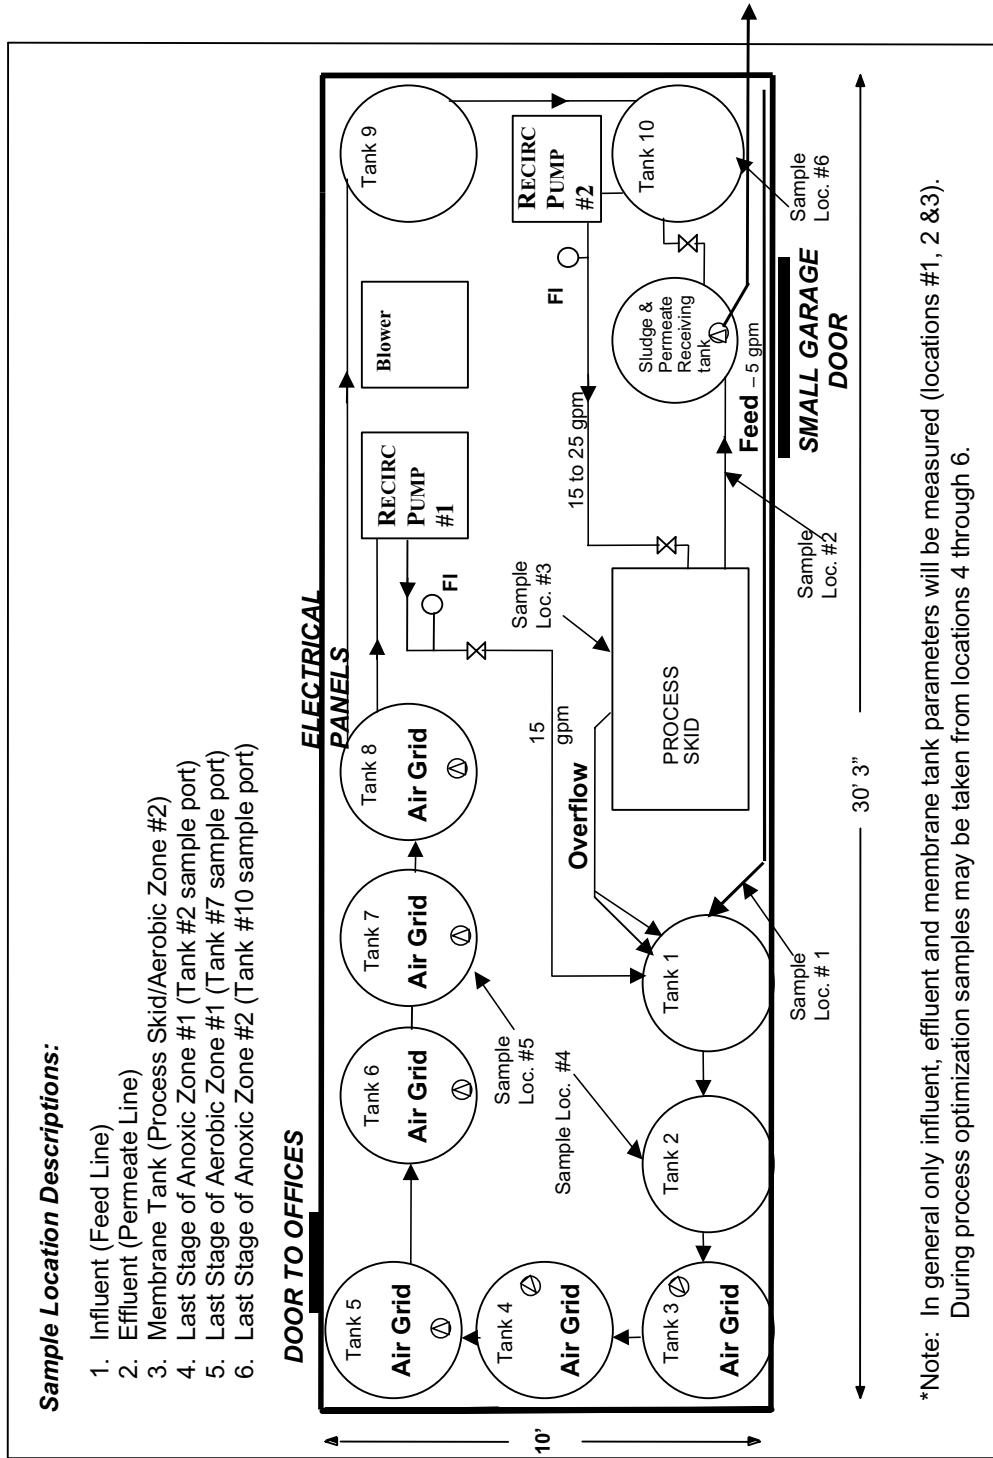
**Figure 3-2** Twelve Pines STP MBR Demonstration Layout (April 10 – August 26, 2001)

1. **FEED PUMP:** 150 ft. away and down 8 ft. with an in-line basket strainer, pumped from center of primary clarifier.
2. **WASTE SLUDGE:** gravity feed to sludge holding tank then pumped to primary clarifier influent channel.
3. **PERMEATE:** discharged to sludge holding tank then pumped to primary clarifier influent channel.
4. **CLEAN WATER SUPPLY:** 60 psig tap water.

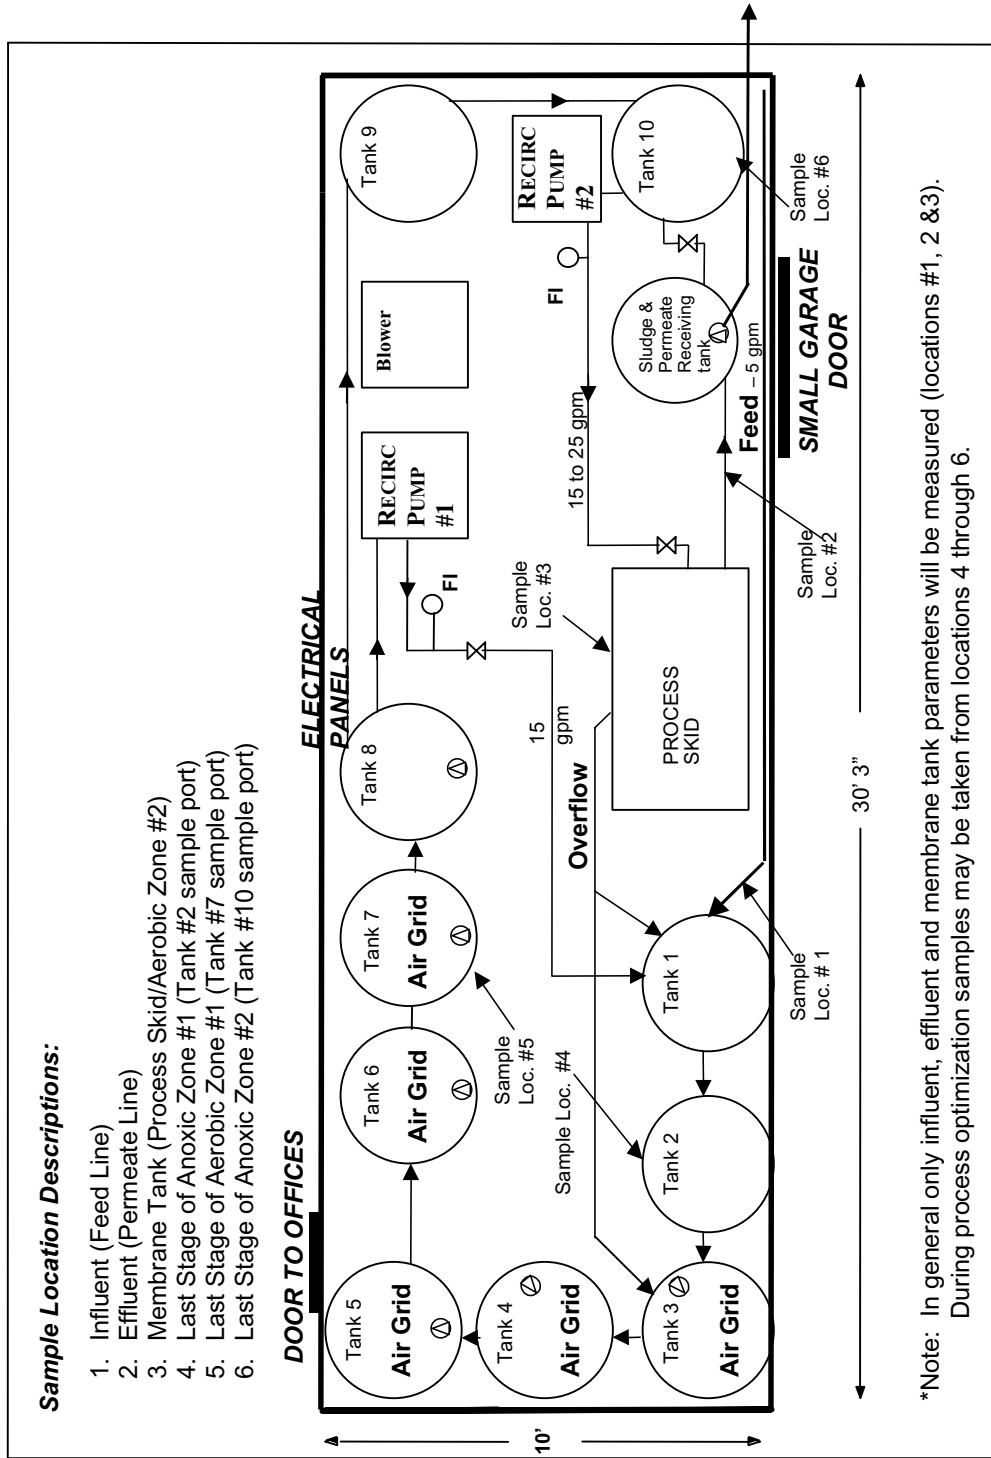
**Figure 3-4** Twelve Pines STP MBR Demonstration Layout (August 26 – November 7, 2001)

1. FEED PUMP: 150 ft. away and down 8 ft. with an in-line basket strainer, pumped from center of primary clarifier.
2. WASTE SLUDGE: gravity feed to sludge holding tank then pumped to primary clarifier influent channel.
3. PERMEATE: discharged to sludge holding tank then pumped to primary clarifier influent channel.
4. CLEAN WATER SUPPLY: 60 psig tap water.

The configuration of the anoxic and aerobic tanks were changed twice during the study. Figure 3-4 is the pilot layout after the first change and this configuration was used from August 26 to November 7, 2001. Basically, Tank 8 was converted to anoxic operation and the overflow from the Membrane Tank was re-routed to Tank 3. Figure 3-5 is the process flow schematic for the layout shown in Figure 3-4. Later, it was found that the overflow from the Membrane Tank had two outfall connections and the second configuration change was to rectify this situation by re-routing the second connection to Tank 3.

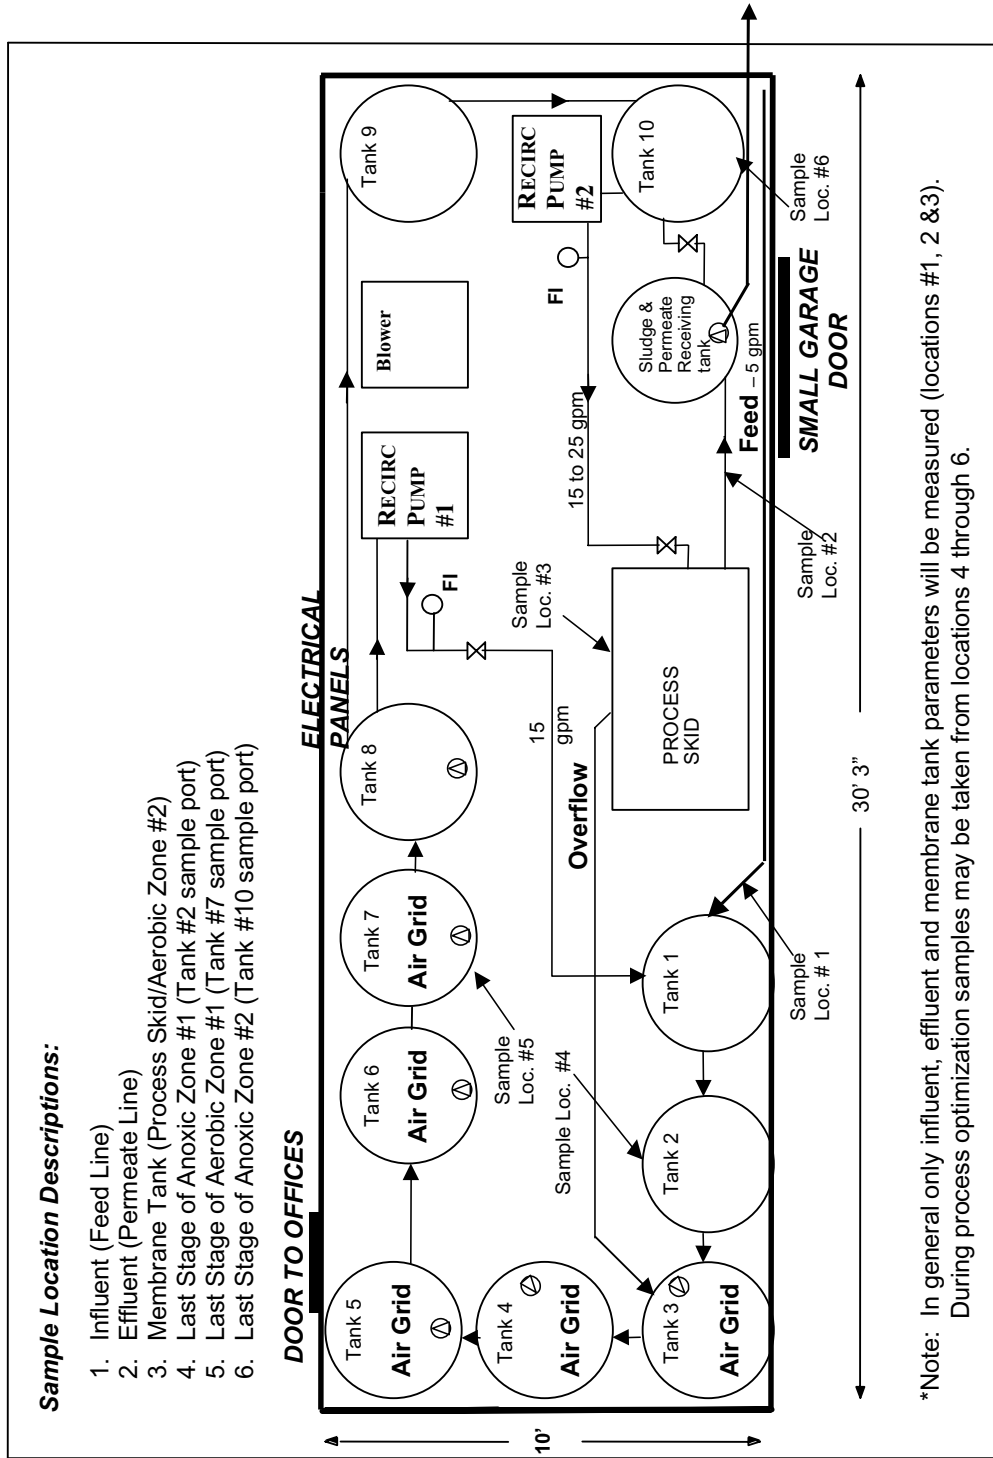
Figure 3-6 Twelve Pines STP MBR Demonstration Layout (November 7, 2001 – February 7, 2002)

1. FEED PUMP: 150 ft. away and down 8 ft. with an in-line basket strainer, pumped from center of primary clarifier.
2. WASTE SLUDGE: gravity feed to sludge holding tank then pumped to primary clarifier influent channel.
3. PERMEATE: discharged to sludge holding tank then pumped to primary clarifier influent channel.
4. CLEAN WATER SUPPLY: 60 psig tap water.

The second configuration change is shown in Figures 3-6 (layout) and 3-7 (process schematic). In this configuration, the influent wastewater was passed through an anoxic zone before it was combined with the overflow from the Membrane Tank and sent to the aerobic zone.

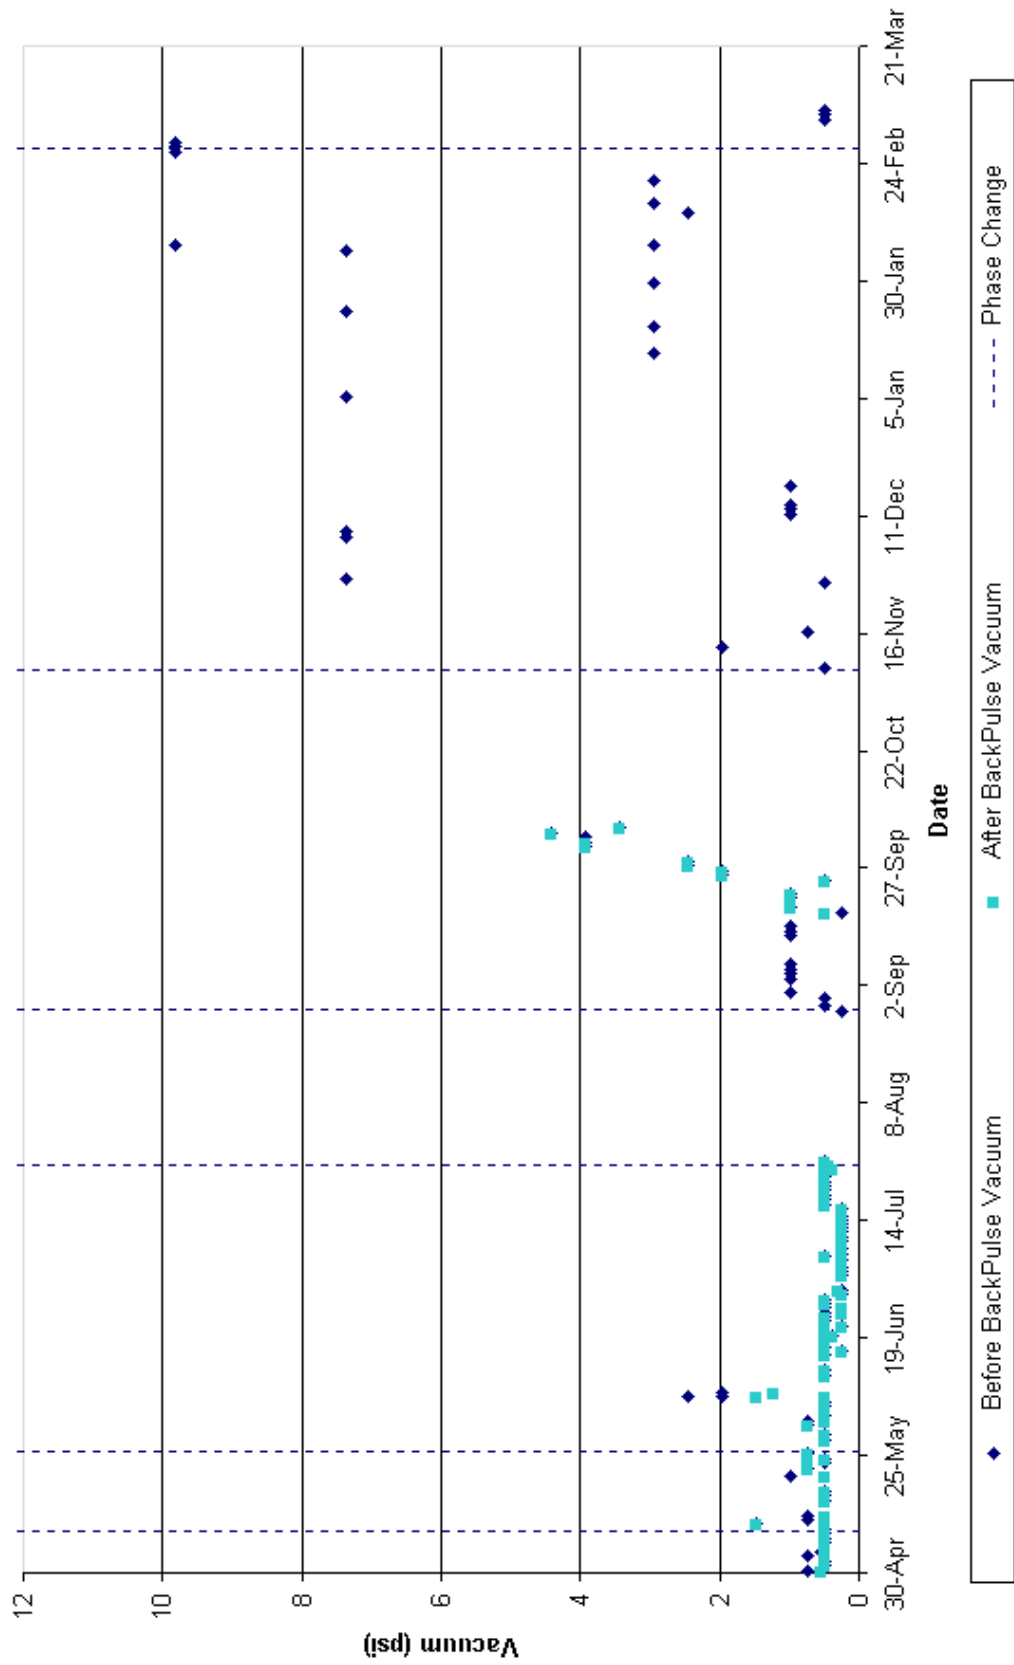
Figure 4-2: Before and after backpulse vacuum.

Figure 4-2 shows the transmembrane pressure difference in psi. The vacuum pressures before and after backpulsing operations are plotted. As discussed below, backpulsing is a means of reducing the pressure drop across the membrane, and Figure 4-2 corroborates this effect. Over the course of the study, the system vacuum was not consistently recorded, however high vacuum alarms were noted on several occasions. Aerating the membranes restored the system vacuum on each occasion.

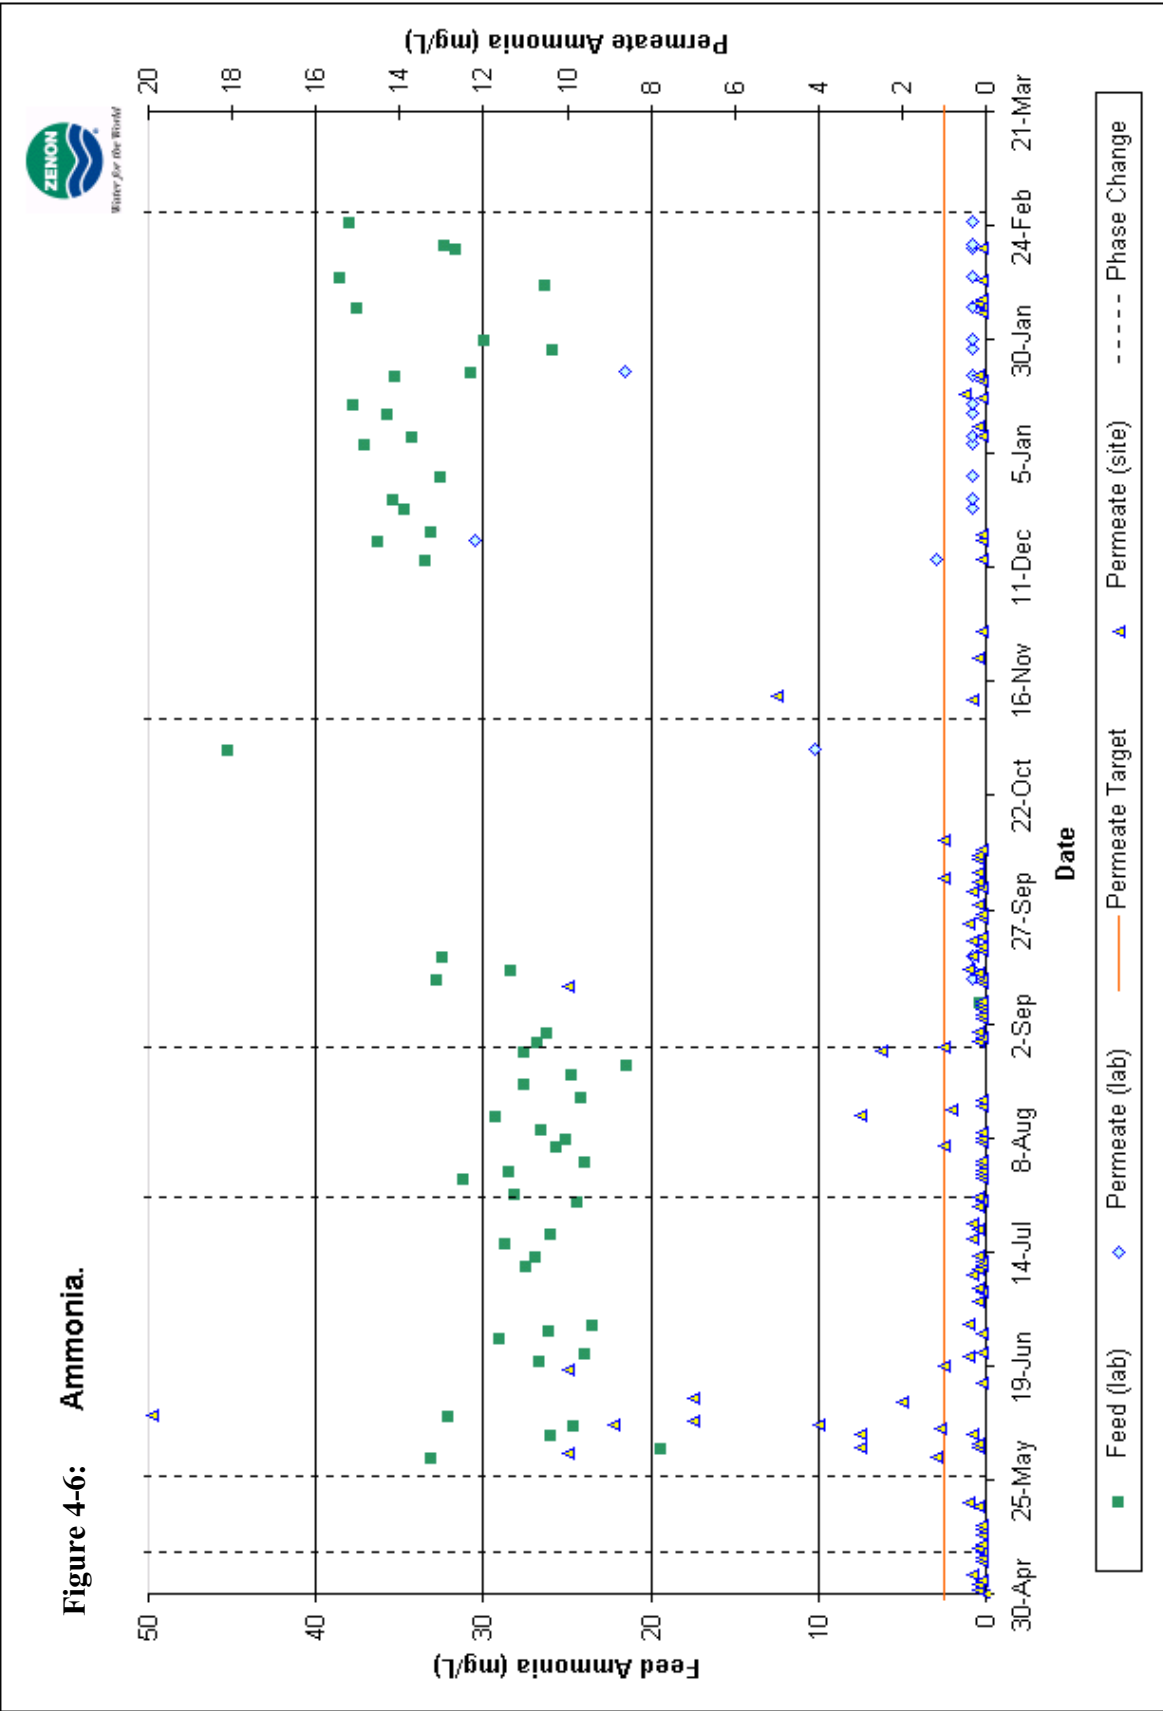
Figure 4-6 shows the ammonia-nitrogen levels in the feed and permeate. Feed ammonia-nitrogen was measured between 19 and 45 mg/L. Based on results from the site, permeate ammonia-nitrogen ranged from 0.01 to 19.9, averaging 1.0 mg/L. After optimizing for nitrogen removal, 95% of the data points collected showed ammonia-nitrogen less than 1.0 mg/L in the permeate, which is indicative of near complete biological nitrification.

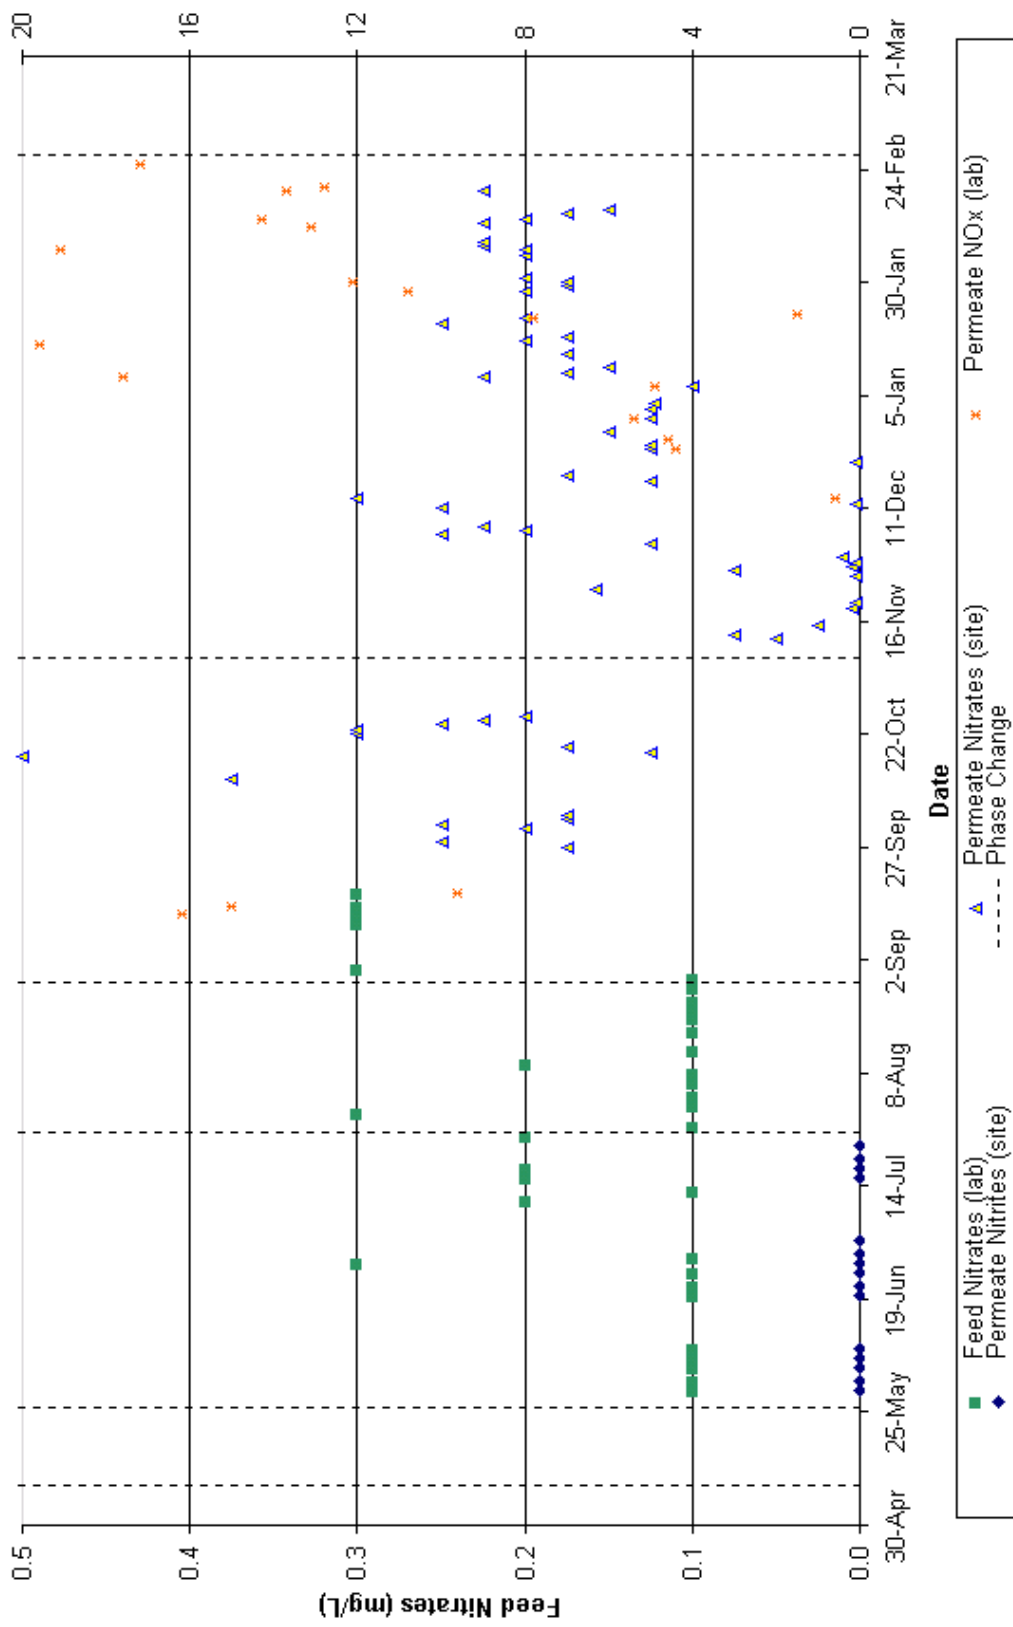
Figure 4-7: Nitrates and Nitrites.

Feed and permeate nitrite/nitrate levels are shown in Figure 4-7. Nitrites are short lived intermediate species that will not accumulate in a healthy nitrification system. Feed nitrates ranged from 0.1 to 11.5 mg/L based on lab results. Permeate nitrate levels recorded on site fluctuated from 0.1 to 20 mg/L. High nitrate concentrations were seen at the end of the study, when BOD<sub>5</sub> levels in the permeate were also high. It is thought that a number of shutdowns resulted in poor microorganism health, which in turn affected the denitrification step of the process.

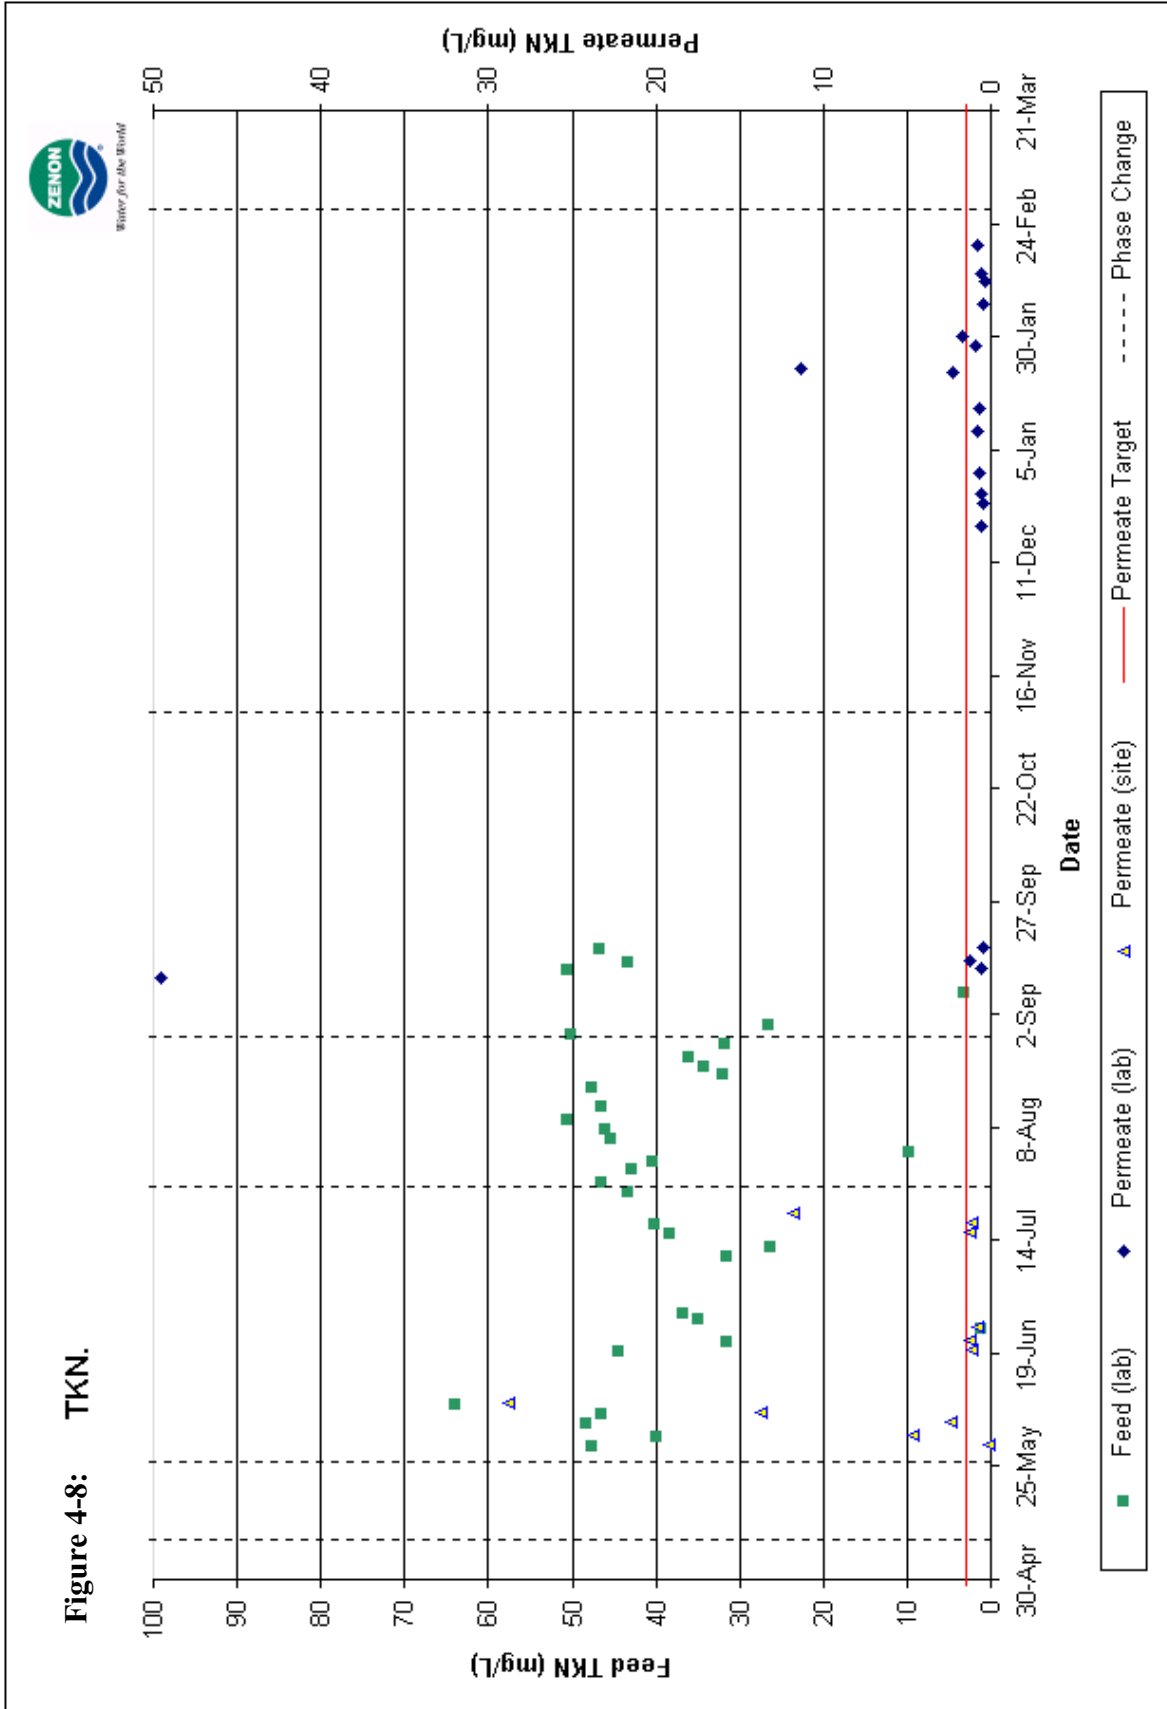
Figure 4-8 shows the Total Kjeldahl Nitrogen (TKN) levels in the permeate, measured both at the lab and on site. At the beginning of the study, the TKN measured by the site ranged from 0.1 to 29 mg/L. However, from September to the end of the study, the permeate TKN was consistently less than 1.5 mg/L, as measured by the lab.

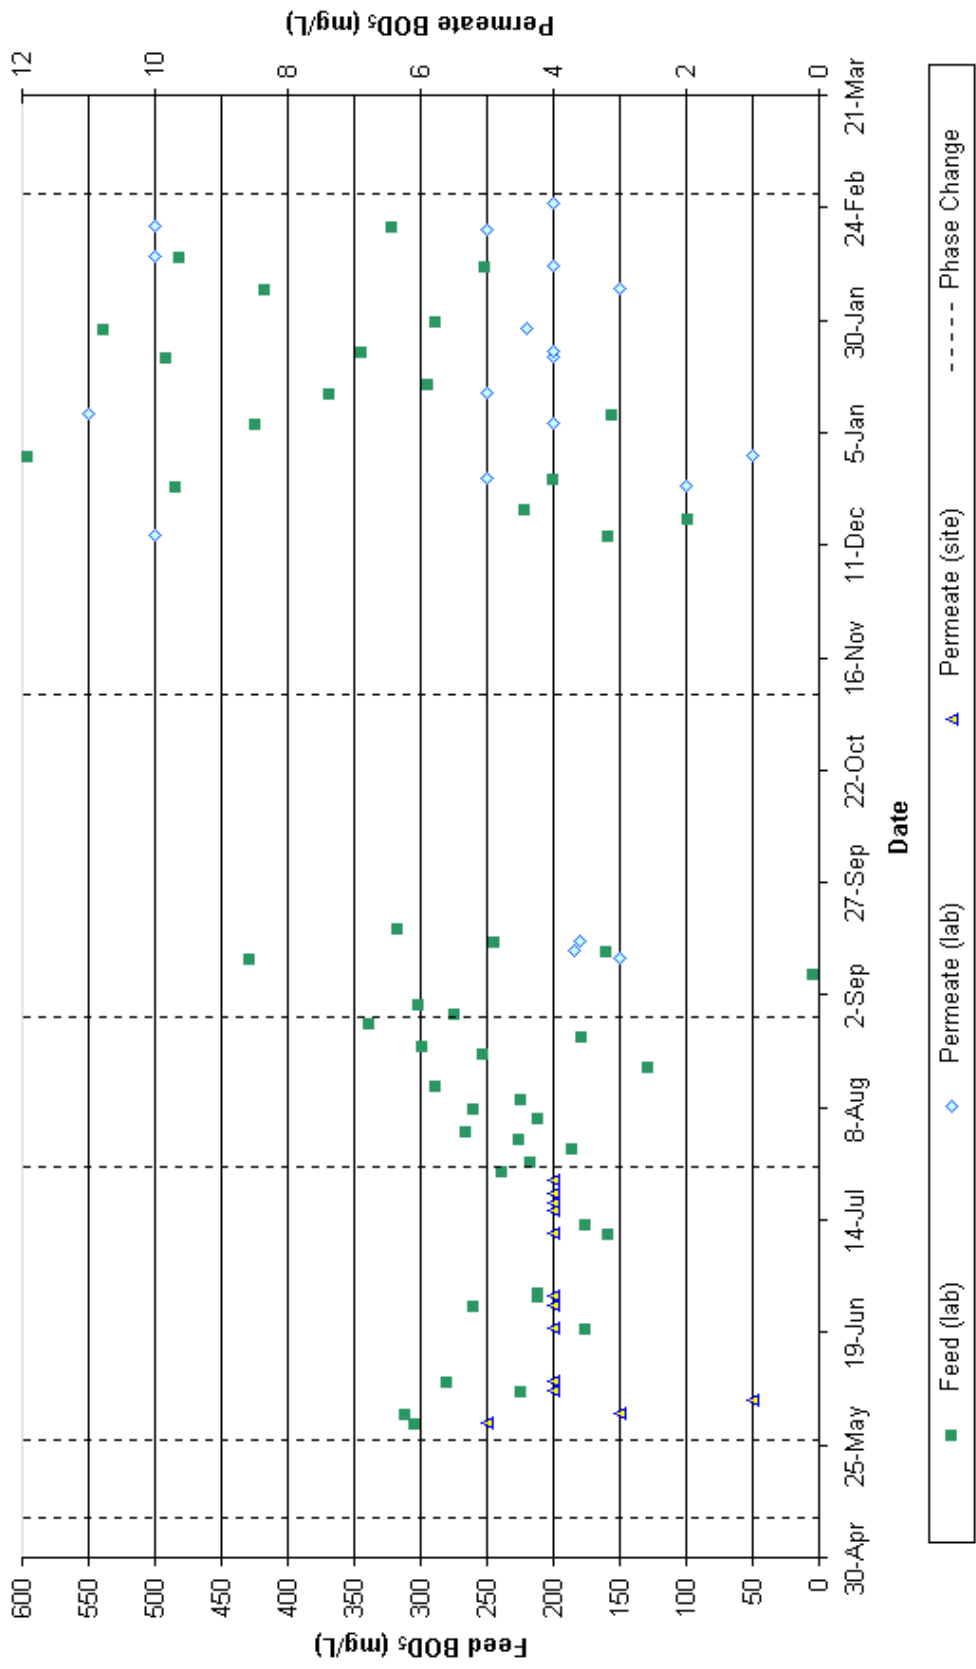
Figure 4-10: BOD<sub>5</sub>.

Biochemical oxygen demand is a measurement of the amount of DO required to meet the metabolic needs of the microorganisms in order to degrade the organic matter in wastewater. Figure 4-10 shows the BOD<sub>5</sub> profile. During the first few months of the study, permeate BOD<sub>5</sub> levels less than 5 mg/L were consistently achieved. From November 2001 to February 2002, the permeate BOD<sub>5</sub> concentration was much more

sporadic, ranging from 1 to 11 mg/L. These BOD<sub>5</sub> levels are indicative of poor microorganism health in the latter portion of the study, likely due in part to the number of shut downs experienced during this time.

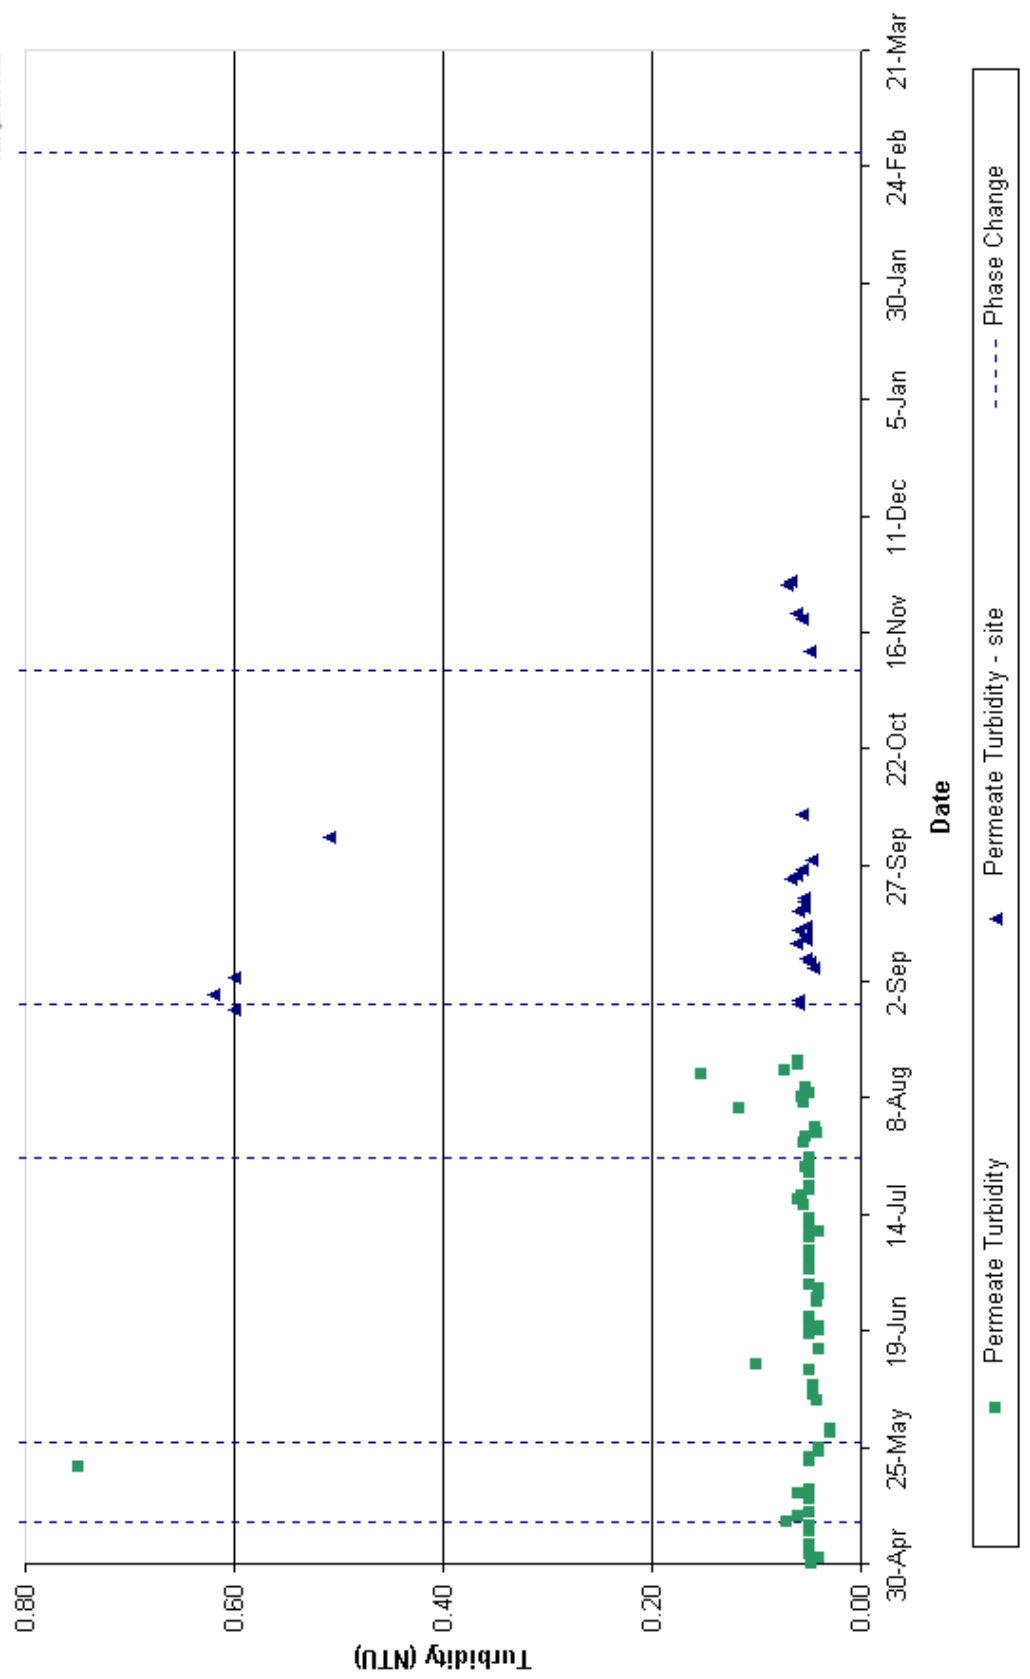
Figure 4-11: Permeate turbidity.

Turbidity is a measure of the clarity of water and is commonly expressed in nephelometric turbidity units (NTU). Suspended solids and colloidal matter, such as clay, silt and microscopic organisms cause turbidity.

The membrane performance throughout the study was exceptional. The data collected shows no breach of membrane integrity, as 96% of the measurements had turbidity values less than 0.1 NTU.
